INFORMATION 108

SEPTEMBER 2008

Reporting on Brick and Tile in Commercial Archaeology

SOME BRICK KILNS AND BRICK MAKERS OF EAST LINCOLNSHIRE

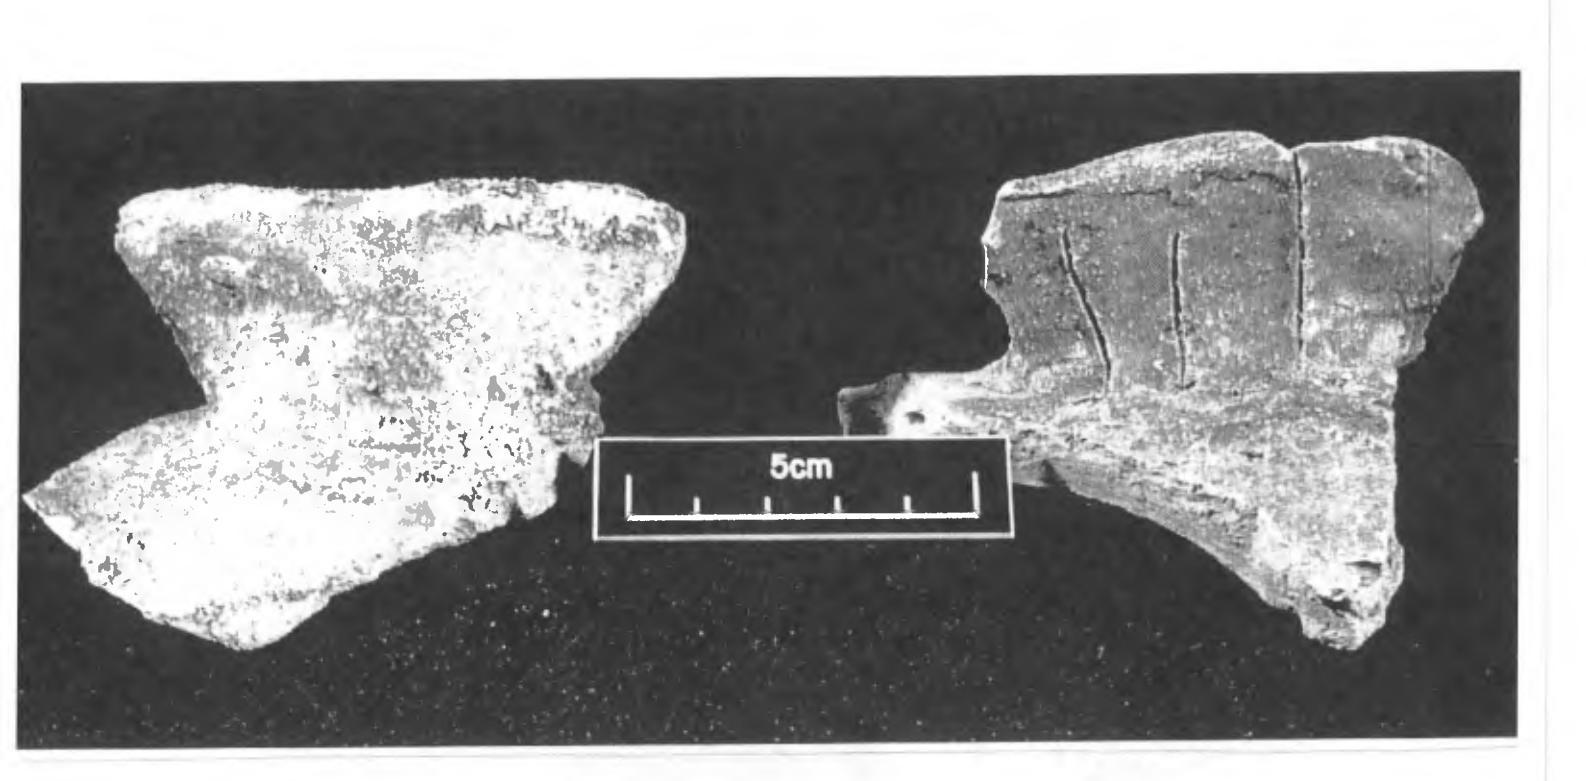
Fig. 1 Ridge tile from Stanion, Northamptonshire.

slashes similar to those seen on jug handles, a device for decreasing firing time on thicker areas of clay (fig 1).

Roof tile was found during the excavation of waster pits at Stanion, a village which was part of a medieval pottery industry in the north-east of Northamptonshire near Rockingham Forest. These pits contained the debris, amounting to about half a tonne of pottery dated to the fourteenth and fifteenth centuries, from nearby medieval pottery kilns possibly still surviving under nearby house plots². There was a substantial quantity of green-glazed ridge tiles, 44.8 kg, mainly concentrated in two pits, virtually all with an 'anvil' design crest, some 'decorated' with

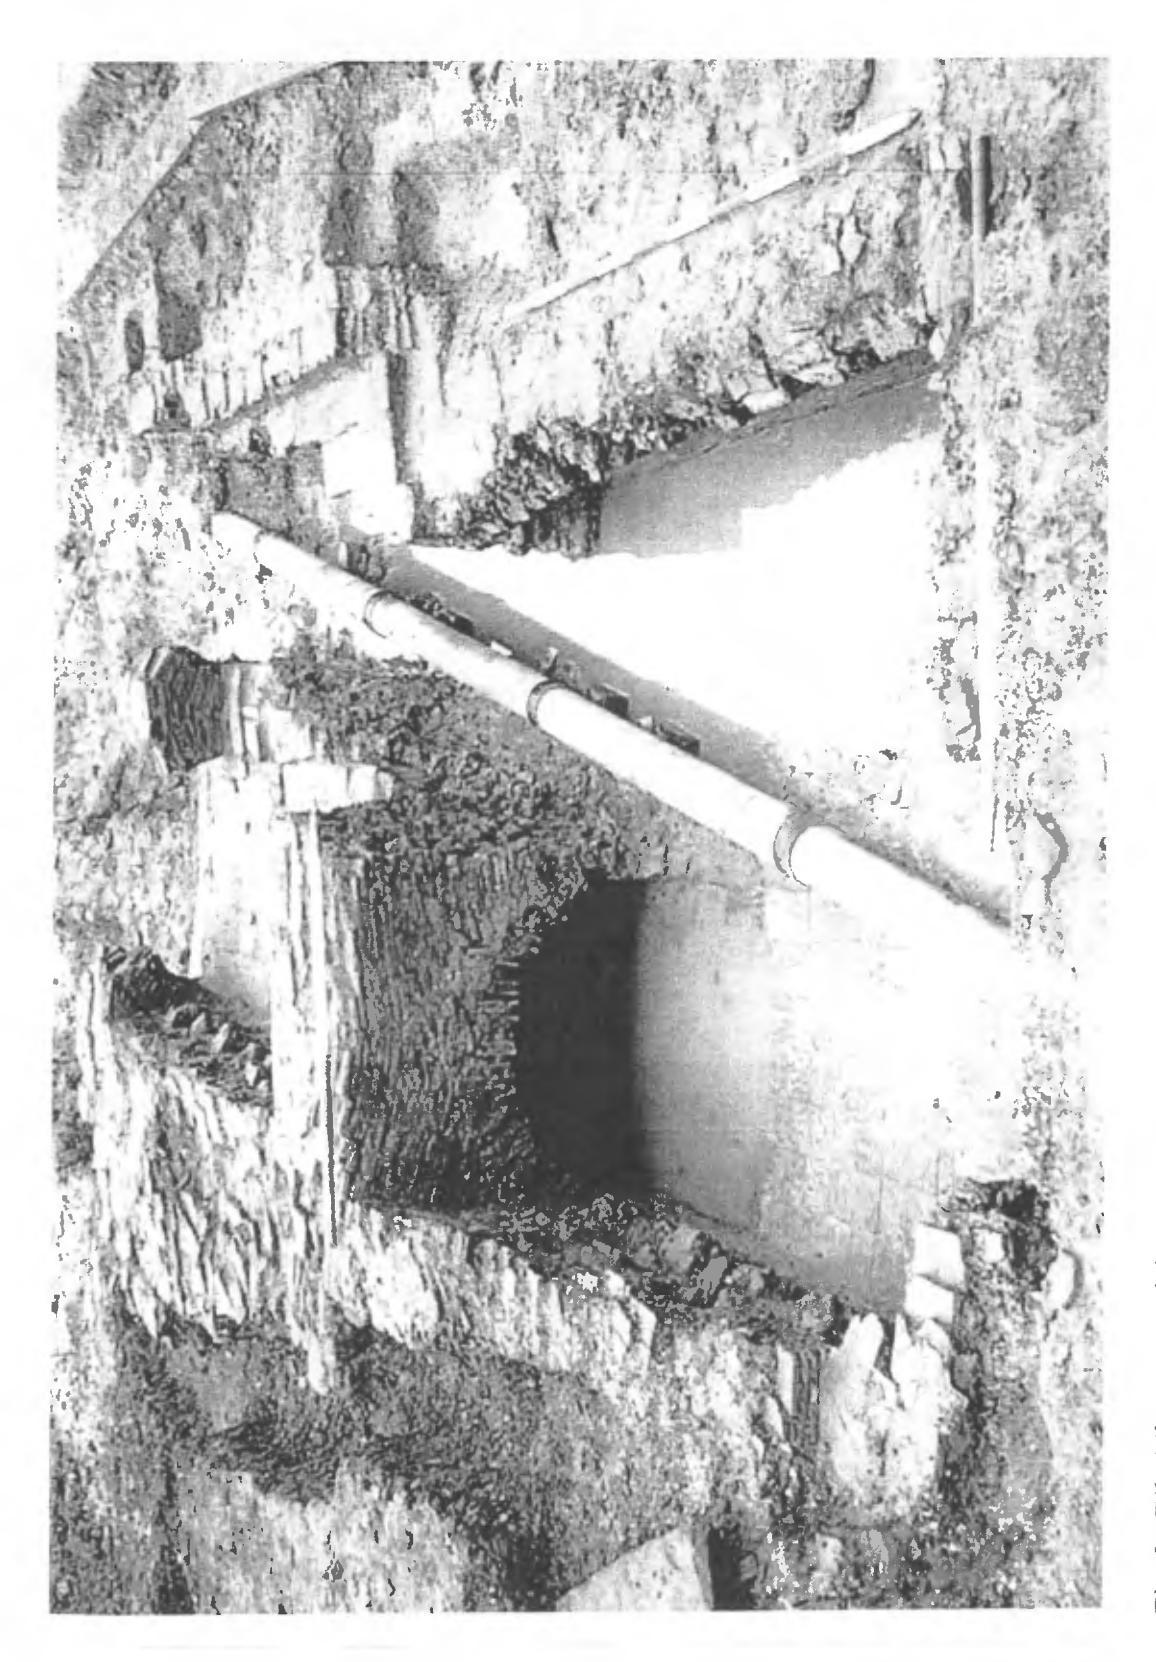
The Warwick tile kiln was 2.90 m long and 2.40 m wide and divided by a central axial wall into two semicircular vaulted flues supporting a single firing chamber (fig 2). The walls were built entirely of whole and broken roof tile and tile wasters laid narrow side on into the kiln giving walls about 0.26m-0.30m thick. The floor in each of the flue chambers had been constructed as a mix of sandstone slabs and clay roof tiles laid on a bed of lime mortar. Forming part of the floor of one of the chambers were 49 stamp decorated (encaustic) floor tiles set into the lime mortar base of the kiln³. A second similar kiln was built over this one in the fourteenth or fifteenth century.

Fig. 2 Tile kiln at Warwick

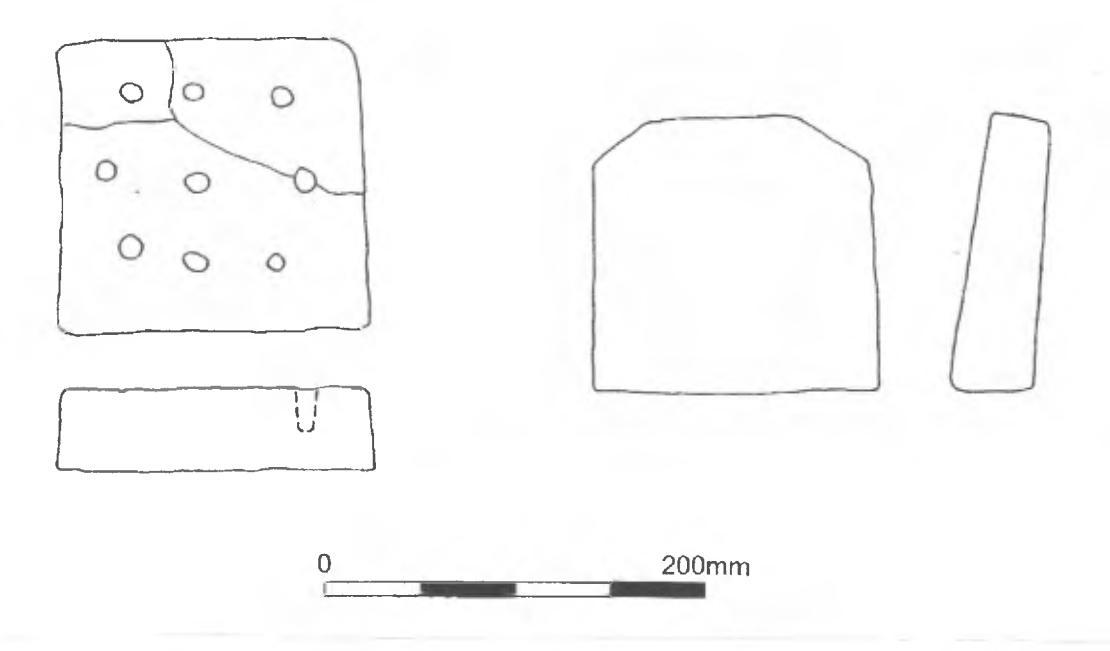
The corner-angled tiles are about 150mm (6 inches) square (fig 3). When laid together the space left by the missing corners would form a diamond, allowing for the circulation of air through the floor of the kiln. These are similar to the structural tiles found in the contemporary thirteenth- to fourteenth-century tile factory at Danbury in Essex⁴. A similar style of tile was also recovered from the seventeenth-to eighteenth-century pottery kiln at Donyatt in Somerset, indicating the longevity of this element of kiln furniture⁵.

Fig. 3 Perforated brick used as kiln furniture at the Warwick tile kiln.

Within the kiln broad flat bricks were used as kiln furniture, either perforated or angled at the corners to allow for the flow of air. These types of construction bricks are interesting, as often they are not recovered. The perforated bricks are typically 160 to 170mm ($6\frac{1}{4}$ to $6\frac{3}{4}$ inches) square and 40 to 45mm ($1\frac{1}{2} - 1\frac{3}{4}$ inches) thick (fig 3). All the surviving edges are chamfered, indicating that they were cast in a mould. They have all been pierced quite deeply on one face with either 8mm square or 10mm in diameter round holes set in a fairly regular pattern, which have become clay filled after being pushed onto a soft surface.

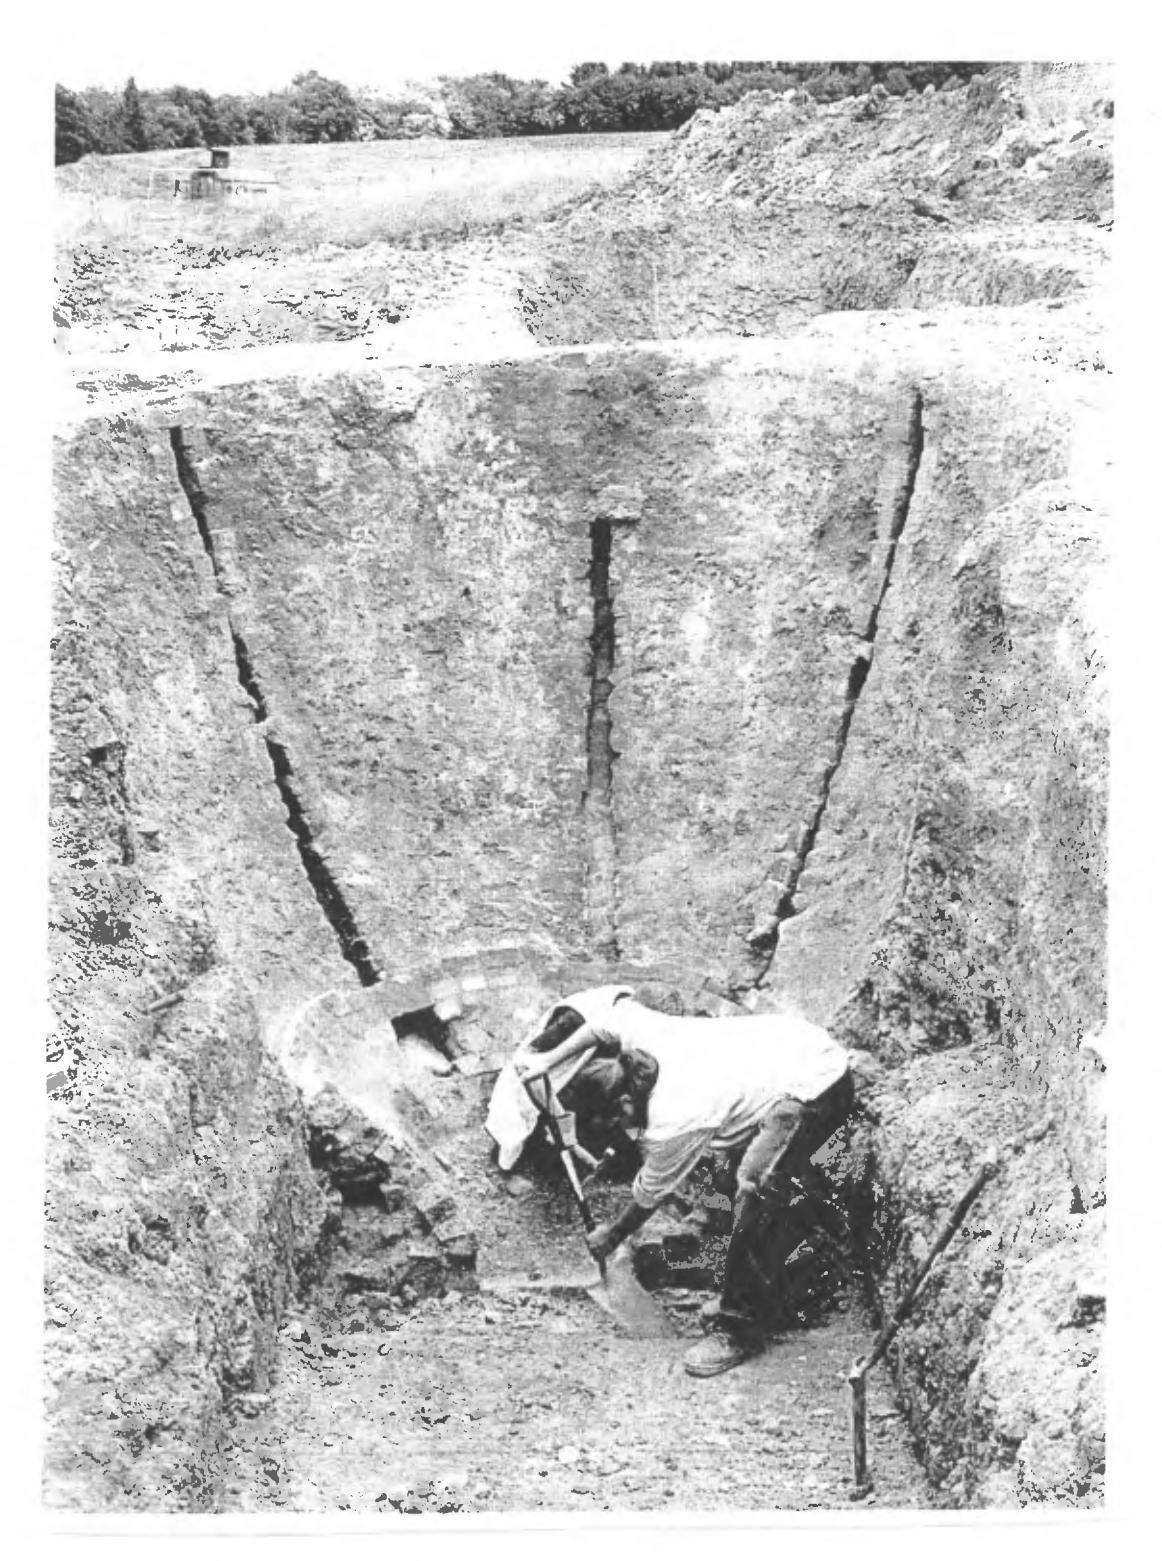
Fig. 4 Brick-lined lime kiln under excavation at Barrow-on-Soar, Leicestershire.

My only substantial brick assemblage to date has been a sample collection from a series of excavated medieval and post-medieval limekilns at Barrow on Soar in Leicestershire, a site with the slightly unfortunate name of Catsick Hill. Three of the excavated 'pot' kilns were circular and between 3m-4m in diameter, 1.8m-2m deep, tapering to a base diameter of 1-1.3m diameter. At the base of each kiln, up to eight courses of bricks survived *in situ*, buried by the demolition debris, showing that the whole internal surface of the kiln had originally been faced in this way. The bricks were bonded with hard white lime mortar and bedded on a floor of bricks. Archaeo-magnetic samples taken from the burnt brick lining of two of these kilns give the dates of last firing in the range 1795-1840 and 1825-1860. The largest kilns uncovered on the site were a development of the brick-lined 'pot' kilns but with the addition of a ring flue around the base and vertical flues up the walls to allow more efficient use of fuel and more economic production of lime (fig 4). These kilns were up to 5m in diameter, tapering to 1.3m at the base and up to 3.5m deep. They each had a steep ramp with steps to allow access to the kiln entrance and working area. The last firing of these kilns was between 1870 and 1910. ⁶

The bricks used in these kilns were plain with no frogs, stamps or makers' marks, presumably produced locally just for this purpose. Those that survived without being vitrified have a slightly friable fabric, pale red to orange brown in colour with inclusions of small gravel in varying degrees of density. The majority of these bricks were, however, highly vitrified from use, thus distorting most of their attributes. At least one stretcher surface, and a few headers, of most of this sample of bricks were subjected to intensive and prolonged heating until the exposed face became blackened and bloated, expanding beyond its original dimensions, often to the point of being vitrified. In some cases this is of a glassy green nature. Many of the bricks were reused as both stretcher surfaces are vitrified. Many of the bricks have streaks or lumps of lime mortar on their top and bottom surfaces. The table gives the dimensions of the bricks.

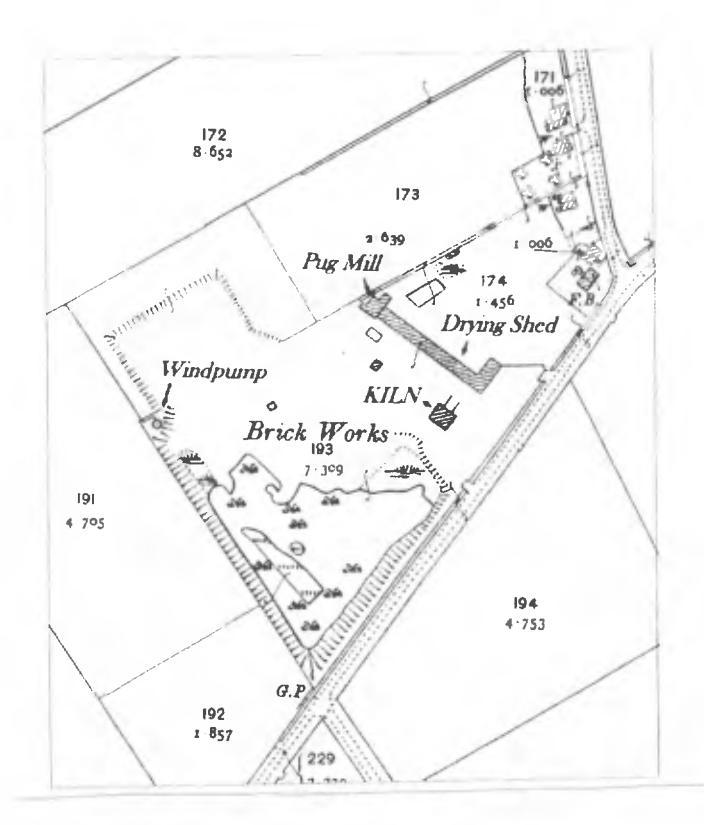
Clay was dug from the surrounding brick pits by hand in the winter and left in heaps to be tempered by weather and frost. In the spring it was passed through a pug or clay mill to create uniform plastic clay of the required consistency. Hand-made bricks were moulded by hand in wooden moulds (usually lined or edged in brass or iron) to create brick-shaped blocks. These 'green' bricks were then stacked in well-spaced rows in large open hacks or drying sheds (fig. 1).

Fig.1. Brickworks at Sutton on Sea, 1906 (Photocopy from 25" OS map 1906, annotated.)

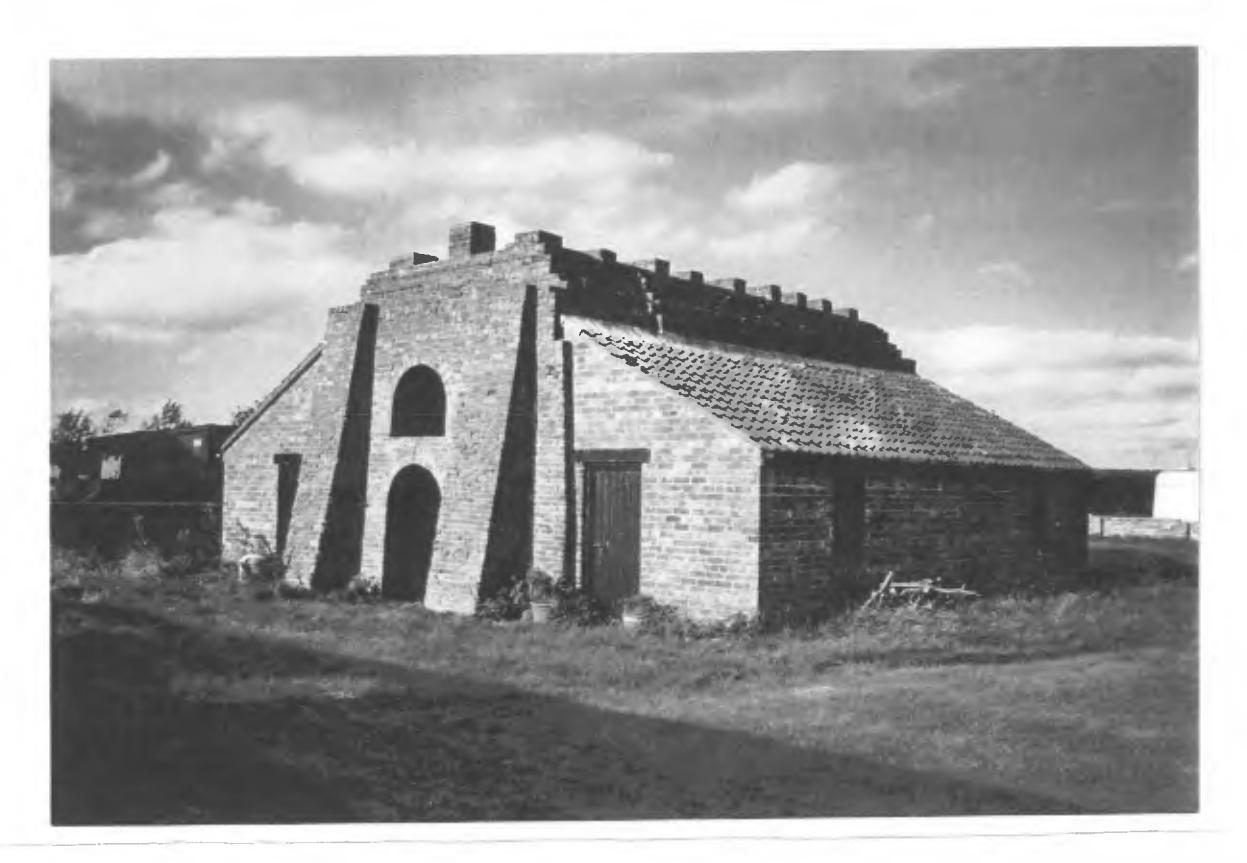
of Stourton Hall. As is the case for all four kilns, it is constructed in local brick (red, in this instance) with fire-brick only used to line the fire-holes. The kiln was operated until the mid-1890s. In 1986/87 extensive restoration work created a new roof with an array of small vent chimneys, lean-to firing sheds and a pair of openings or wickets, one above the other, on the front (south-west) elevation. These changes were designed by the foremost authority on historic kiln features at the time, but it is not clear to what extent they were speculative (fig.2).

Fig.2. Baumber kiln: from the south, 2006 (Photograph – K. Redmore)

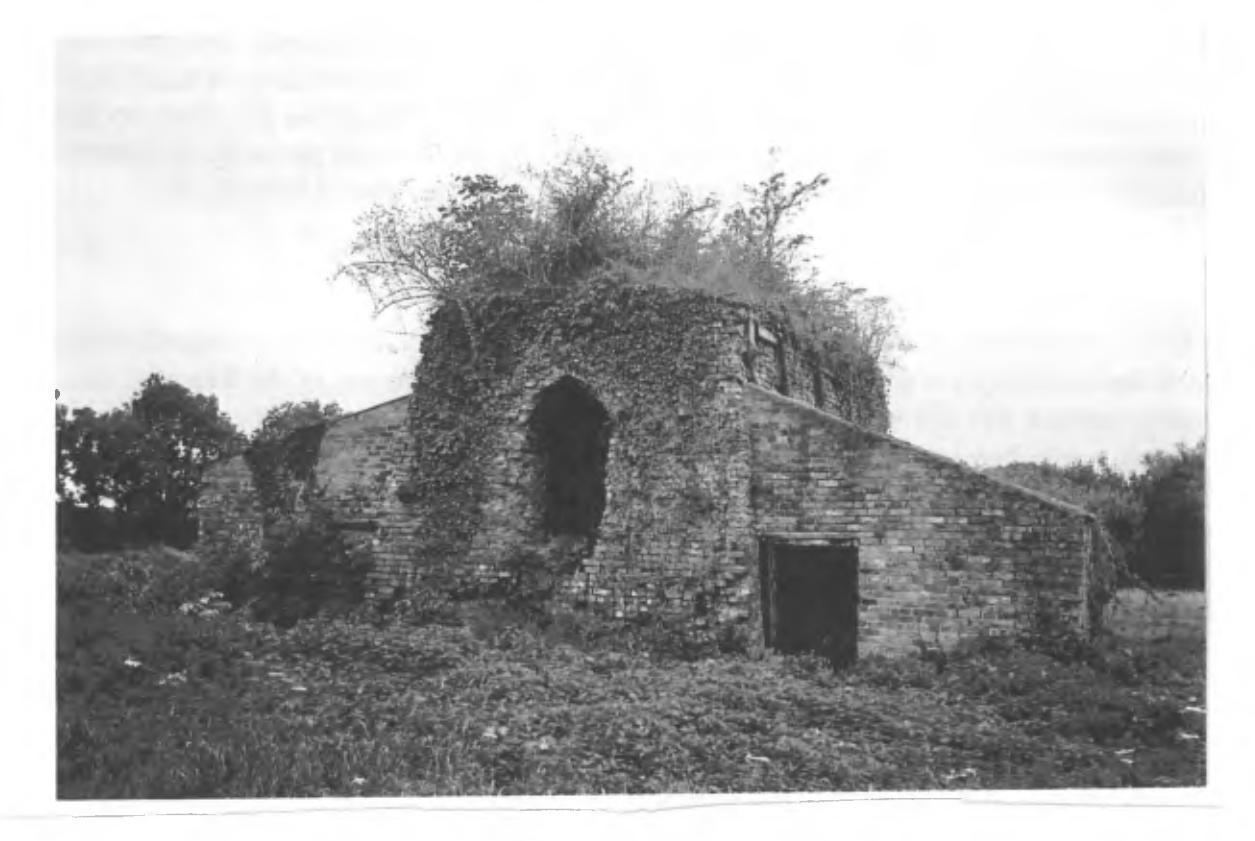
The kiln at Farlesthorpe (TF 480739), built in local yellow brick in about 1855, is coincidentally in one of the few villages where the Livesey family, minor gentry, owners of the Baumber site, also had an interest. The kiln was in use until about 1905, after which time it was probably used as a simple agricultural store almost up to the present day. At some point in the twentieth century a wide opening with sliding door was created on the south-west end of the kiln and the firing sheds abutting either side were re-roofed and restored; they too have served some agricultural purpose. The internal structure of the kiln is currently quite sound; the external roof is covered in vegetation, including tree saplings. The earthen ramp to the wicket (opening) at the rear of the kiln (north-east) was removed in 2006 (fig.3, fig. 4).

Fig.3. Farlesthorpe kiln: north-east elevation, 2006 (Photograph - K. Redmore)

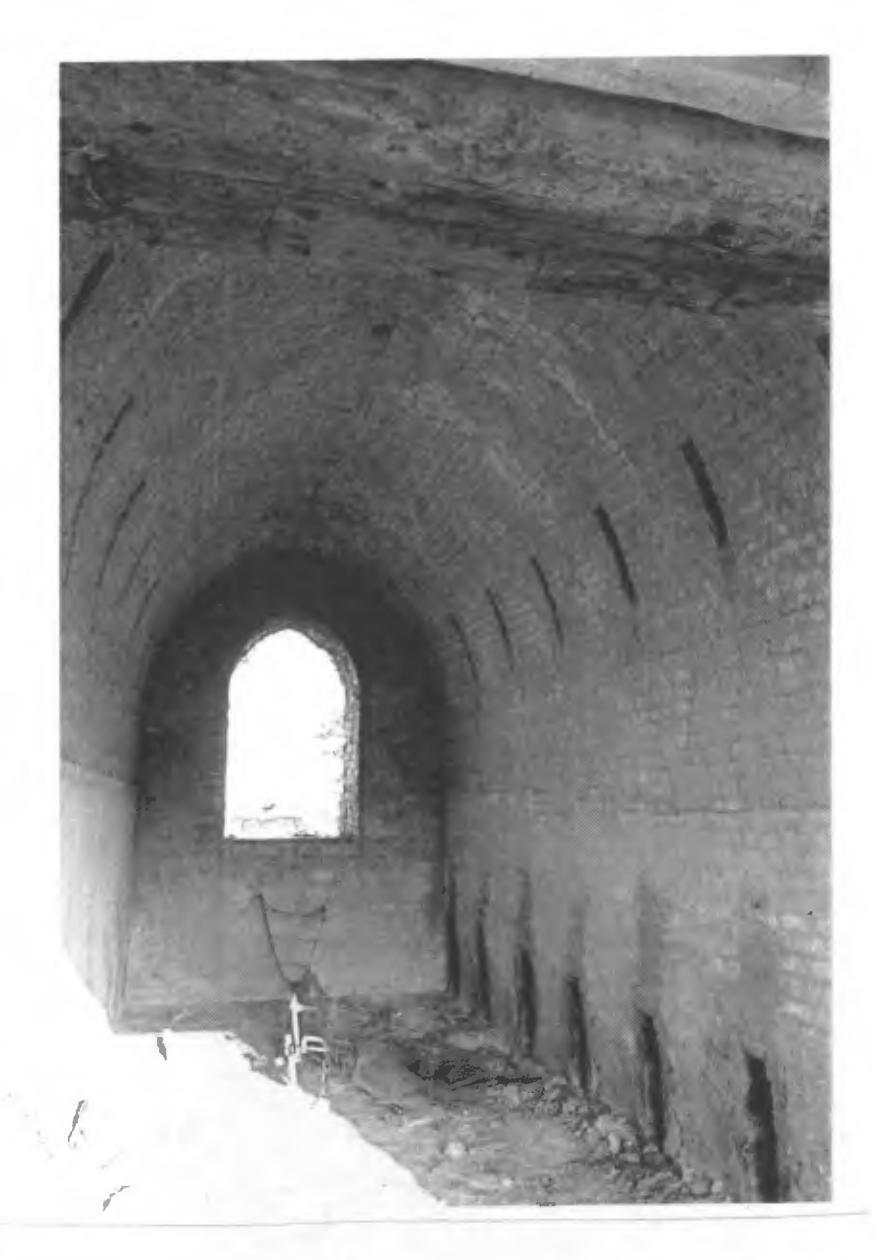
Fig.4. Farlesthorpe kiln: interior, 2005 (Photograph - K. Redmore)

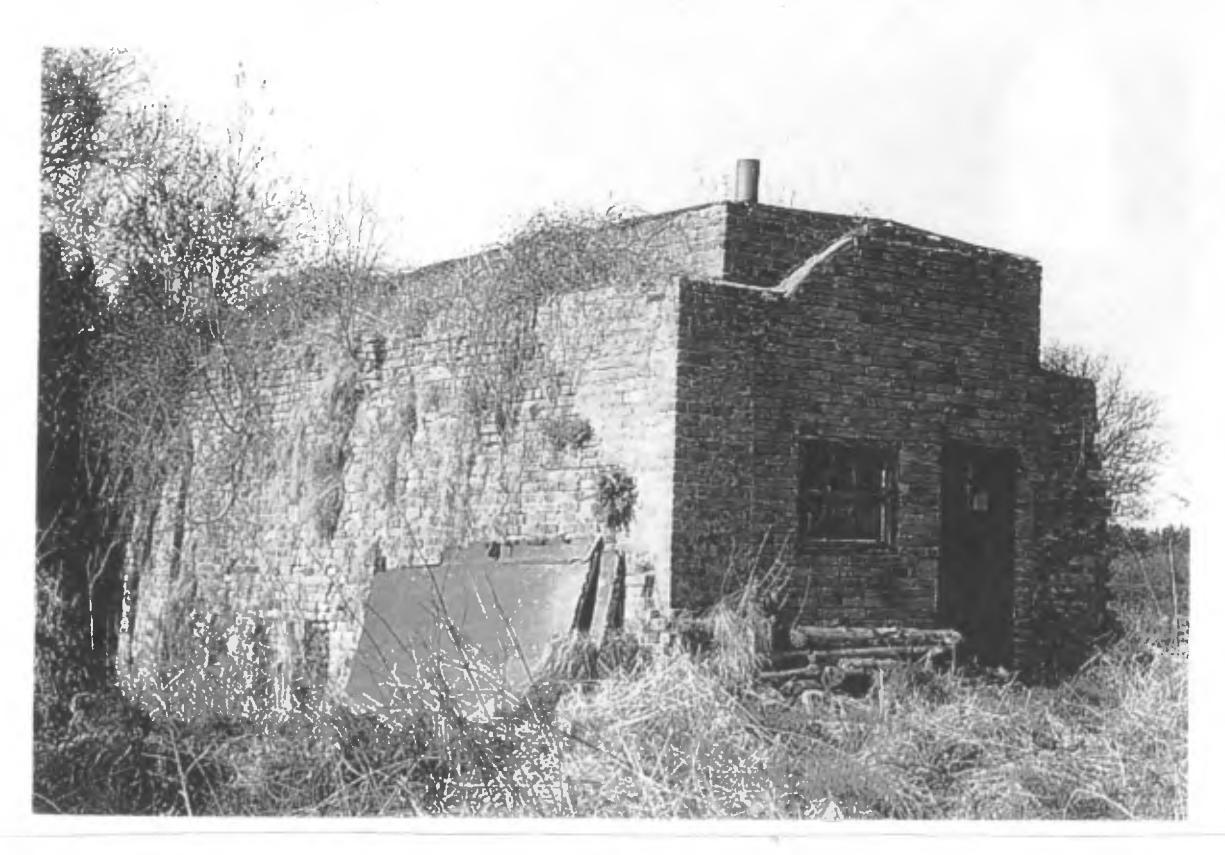
Fig.5. Stixwould kiln: from the south, c. 1975 (Photograph - D.N. Robinson)

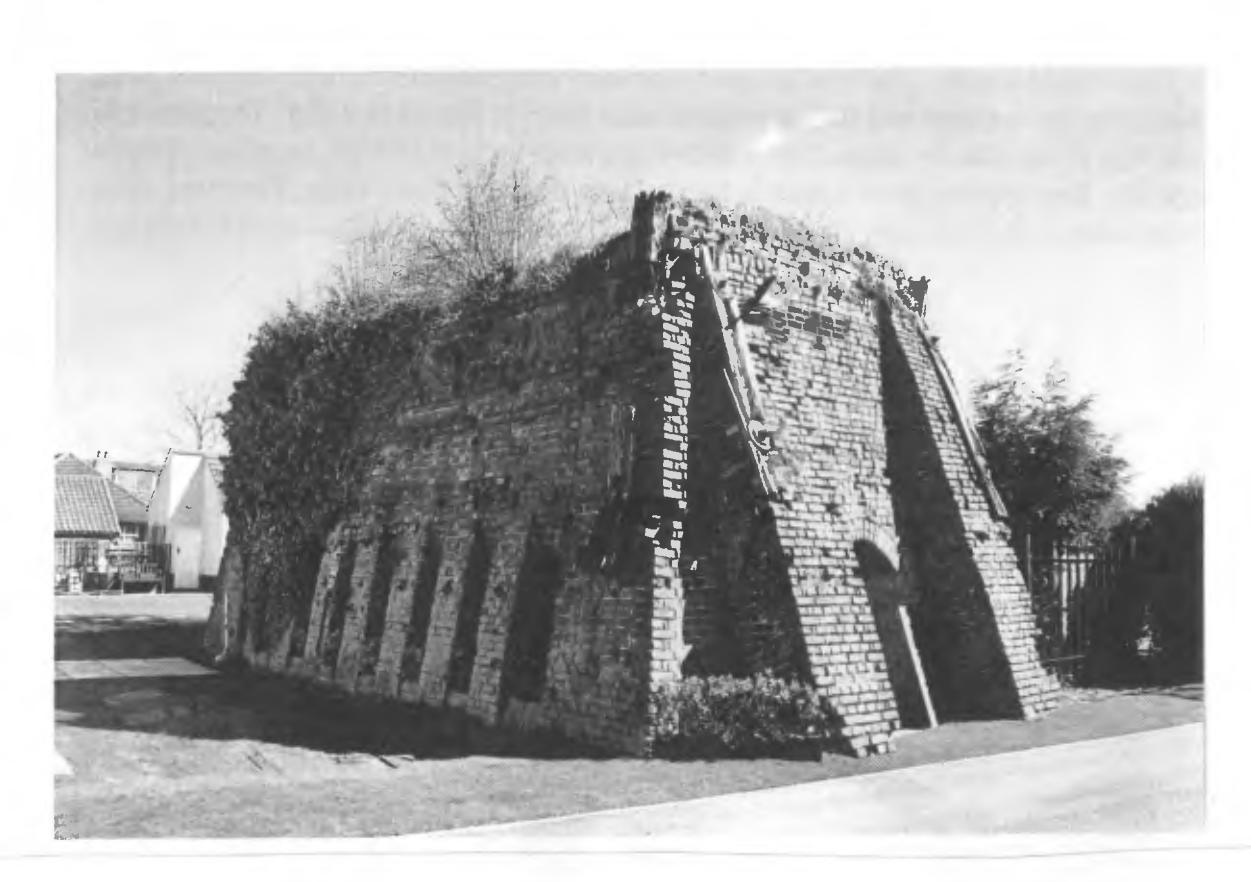
The kiln at Sutton on Sea (TF 504808) was constructed at about the same time as the other three kilns but was in use for a much longer period, until just after 1930. At one point later in the twentieth century it served as a workshop for making firelighters; most recently is has become a simple store on a caravan park. This kiln, in bright red brick, is closest to its original condition; it has neither been restored nor modified. The shape and size of the kiln on the 1906 OS map suggests that there were firing sheds here too, and there are brick paved areas on either side of the kiln today which indicate their extent. Some vegetation on the roof and over one end is beginning to threaten the building but the general condition of external brickwork appears to be sound (fig.6; see also fig. 1).

Fig.6. Sutton on Sea kiln from the west, 2006 (Photograph - K. Redmore)

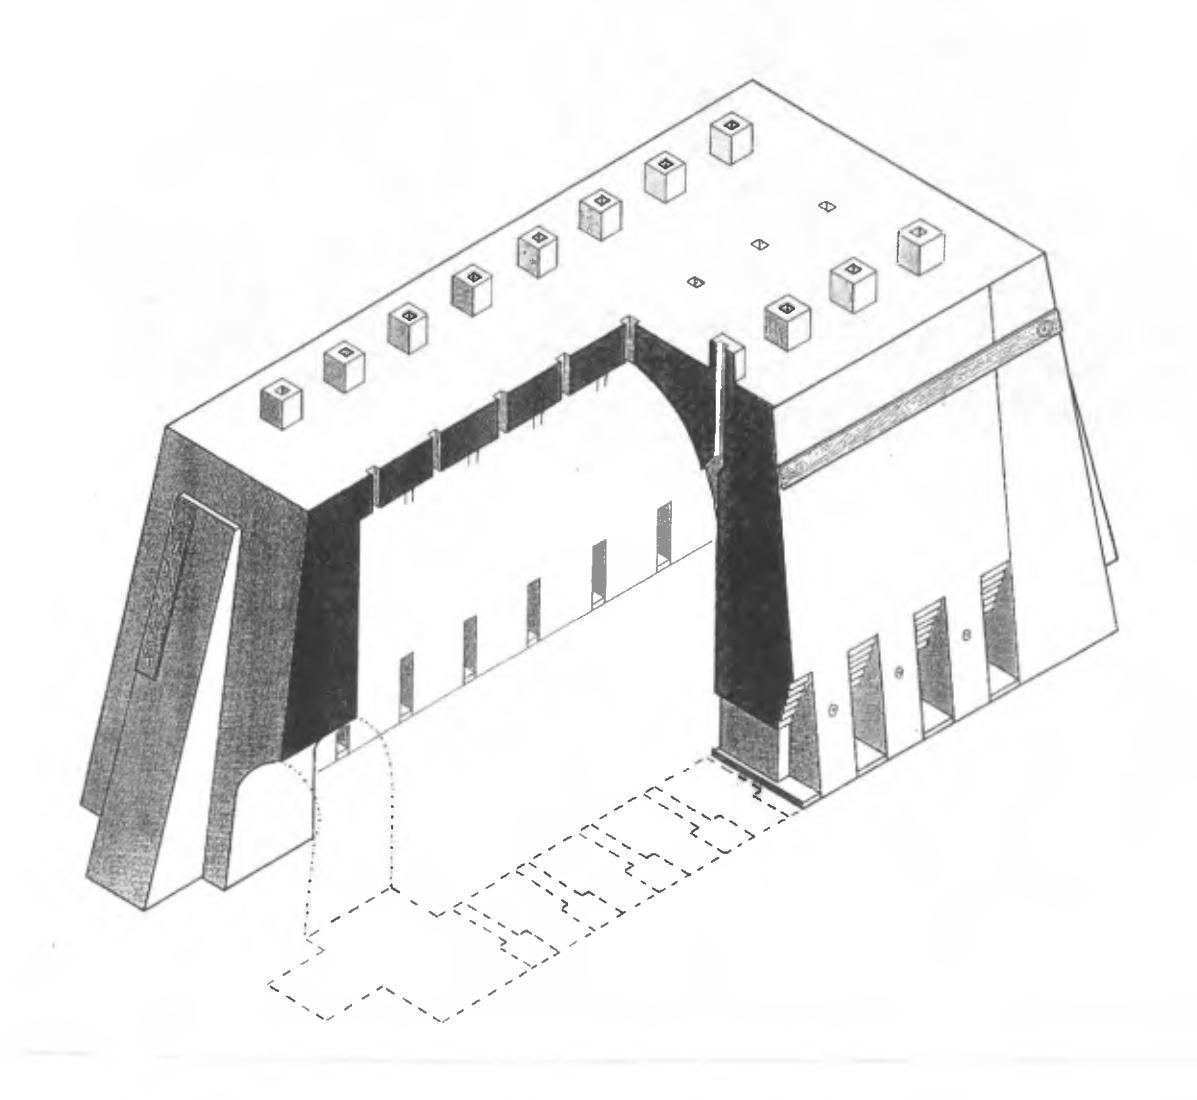
The "East Lincolnshire" Kiln (fig. 7)

Fig. 7 The 'East Lincolnshire' Kiln
The drawing combines actual measurements of the kilns at Farlesthorpe and Sutton-on-Sea together with an impression of the vents as originally proposed by Martin Hammond for the restoration of Baumber kiln in 1986.
(Drawing by K. Redmore)

Firebricks have only been used to line the fire holes and there are variations in the way they are incorporated in this element of the structure: the source of the firebricks is unknown; they would

not have been made locally. The vaulted roofs are each constructed in similar fashion using header bond, but the number and arrangement of vent holes in the roofs differ. The principal vents at the side of the kiln are immediately above fire holes at Farlesthorpe, whereas, perhaps more logically, they are staggered between fire holes at the other three kilns. There are eight central vent holes at Farlesthorpe, nine at Baumber and Stixwould, and eighteen at Sutton-on-Sea.

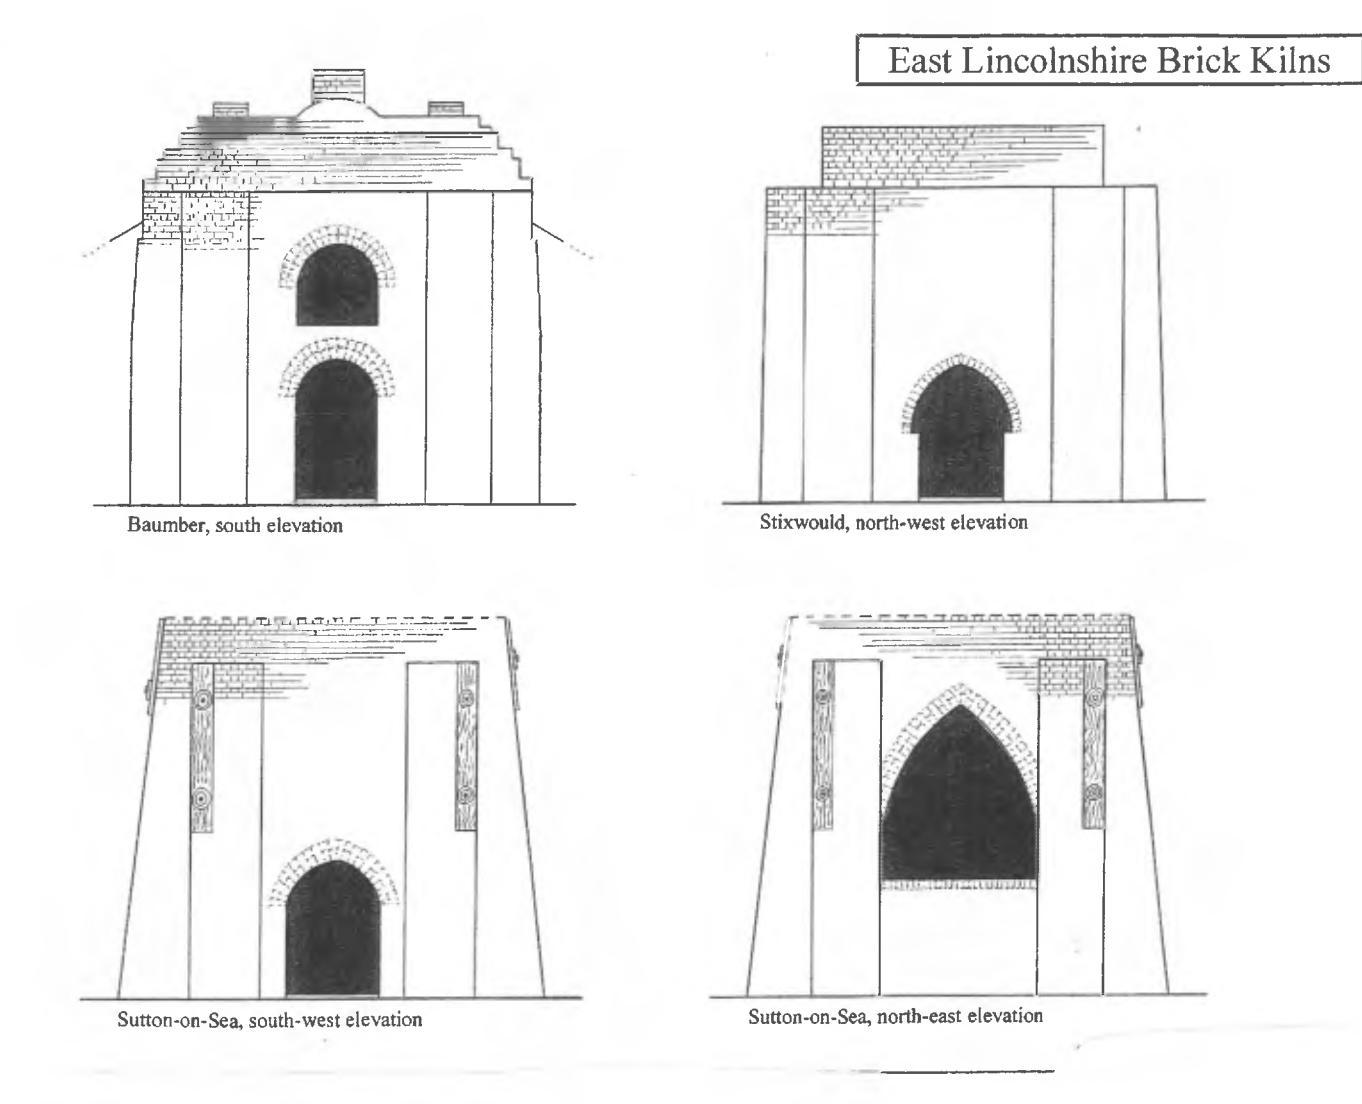
- Fig. 8 Wickets at East Lincolnshire Kilns
 - A. Baumber: south elevation
 - B. Stixwould: north-west elevation
 - C. Sutton-on-Sea: south-west elevation
 - D. Sutton-on-Sea: north-east elevation

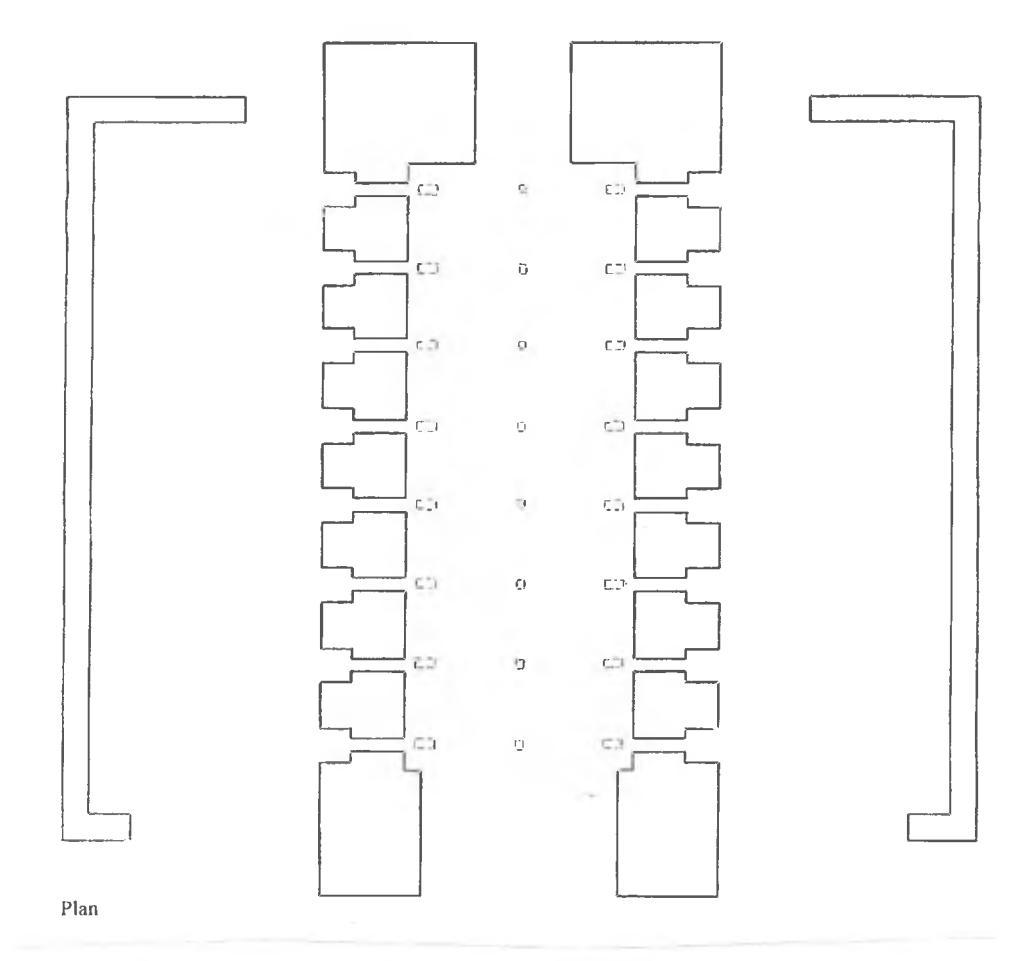
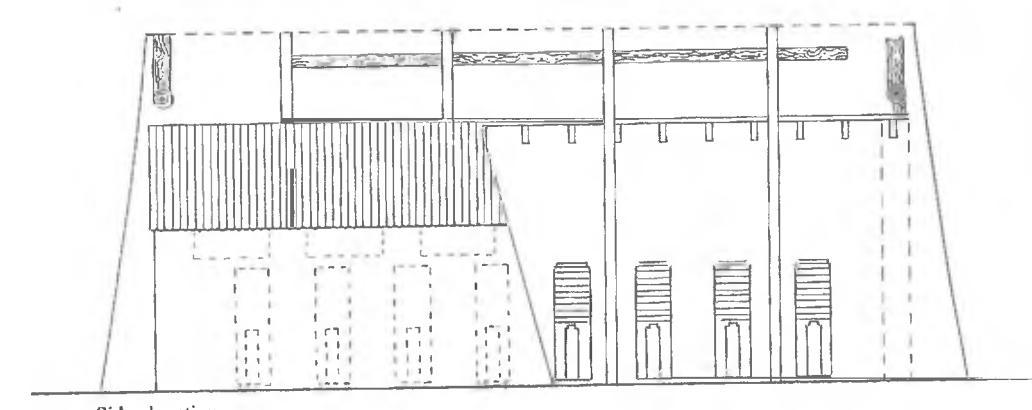
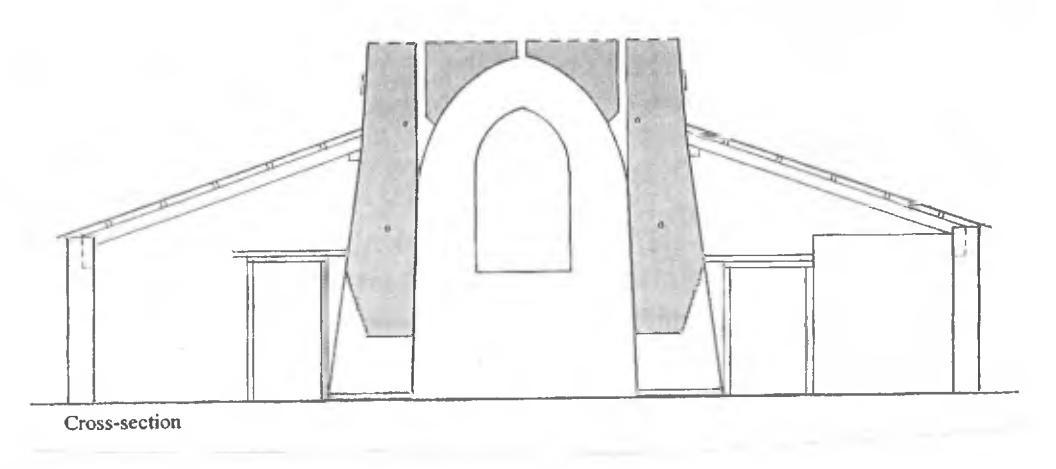
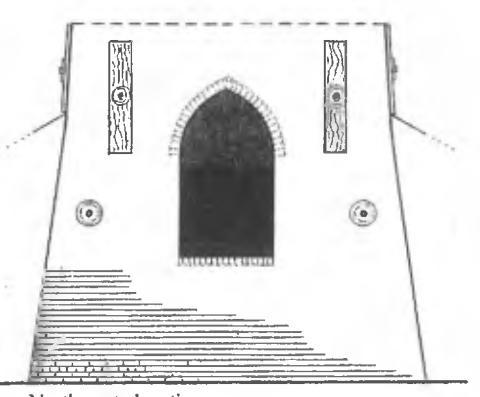
Fig.9. Farlesthorpe kiln: north-east elevation showing wicket and plan. Scale 1:100 (Drawing - K. Redmore)

layout and was constructed using local bricks with some features (e.g. vents, wickets) modified to suit the preferences of the local brickmaker.
