BRITISH BRICK SOCIETY

INFORMATION

52

MARCH 1991

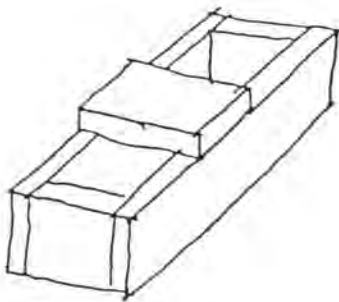
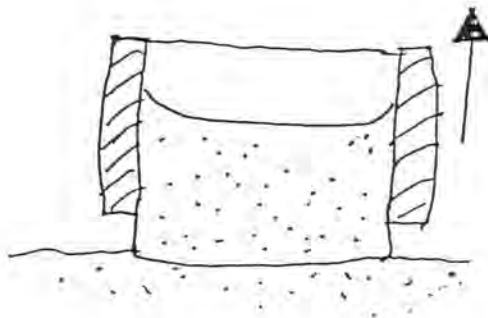
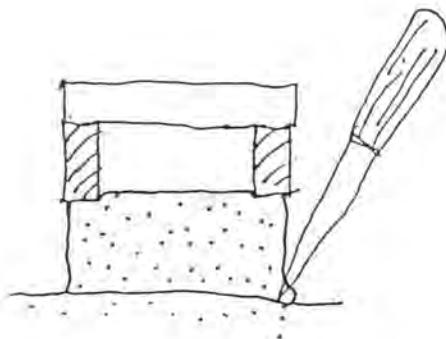
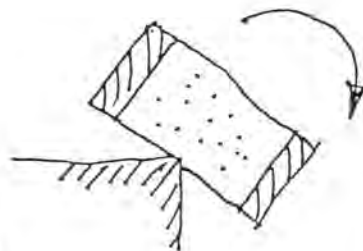
Fig 1 - 5 Stages in working bricks with sunken margins.

During the excavation of a mid-seventeenth-century pottery kiln at Horton, near Wimborne Minster, Dorset, in May 1990 I was able to examine closely a 'production run' of special radial bricks which appeared to have been used to line the kiln chamber. While cleaning and looking at them I thought that they must have been specifically made for this particular job and that the total quantity of bricks was unlikely to have been considerable. The question¹ of repairing of repairing a worn mould, as has been suggested by some authors¹, would not have arisen. All the bricks showed signs of sunk margins to some degree on the top (struck) face; they were deepest on the high spots of the surface, which was not very even. The header, stretcher, and bed faces were sanded: the bed was often very rough; this suggests that the bricks had been made in an open-bottom mould laid on a sanded drying area from sanded clots of clay. The mould was lifted off and the brick left to dry. Because of the unevenness of the ground the clay would in places squeeze out under the bottom edge of the mould. Many bricks showed where this excess had been fettled or trimmed off with a knife when the brick was partly dry and 'leather hard'.

In June 1990 I conducted an experiment in moulding technique at my workshop at Park Farm Museum, Milton Abbas, in order to test my theory. I used an open-bottom steel-lined mould. This was laid on a floor covered with compacted sand, the surface of which was left uneven so that in places the clay would squeeze out under the bottom edge of the mould. Clay rather softer than now normally used for hand-moulding was rolled in dry sand to form a clot which was pressed down rather than thrown into the mould and struck off. The mould was then lifted off and placed next to the finished brick ready for refilling. Some of the bricks were moulded on a bed of straw. The bed face of the brick

After the initial drying period the bricks were stiff enough to handle, perhaps a little too stiff for this experiment. They were then fettled. A template as shown in the sketch (fig 1-5). was made up. This was placed on the top of each brick to push down the edges lifted by withdrawing the mould and to act as a guide for trimming off the excess clay which had squeezed out under the mould with a knife. This was only done as required. Some bricks come out of the mould better than others so needed little or no fettling. Therefore not all bricks in a particular batch would have sunk margins and knife-cut header and stretcher faces. The template certainly produced an authentic-looking sunk margin, even though I had to press quite hard on it because the bricks were drier than I would have liked. The bed face was rough and sandy but the header and stretcher faces were smoother than seventeenth-century examples, probably because a steel-lined mould was used. After fettling the bricks were stacked on edge in a hack to finish drying ready for firing. On the whole the results were satisfactory.

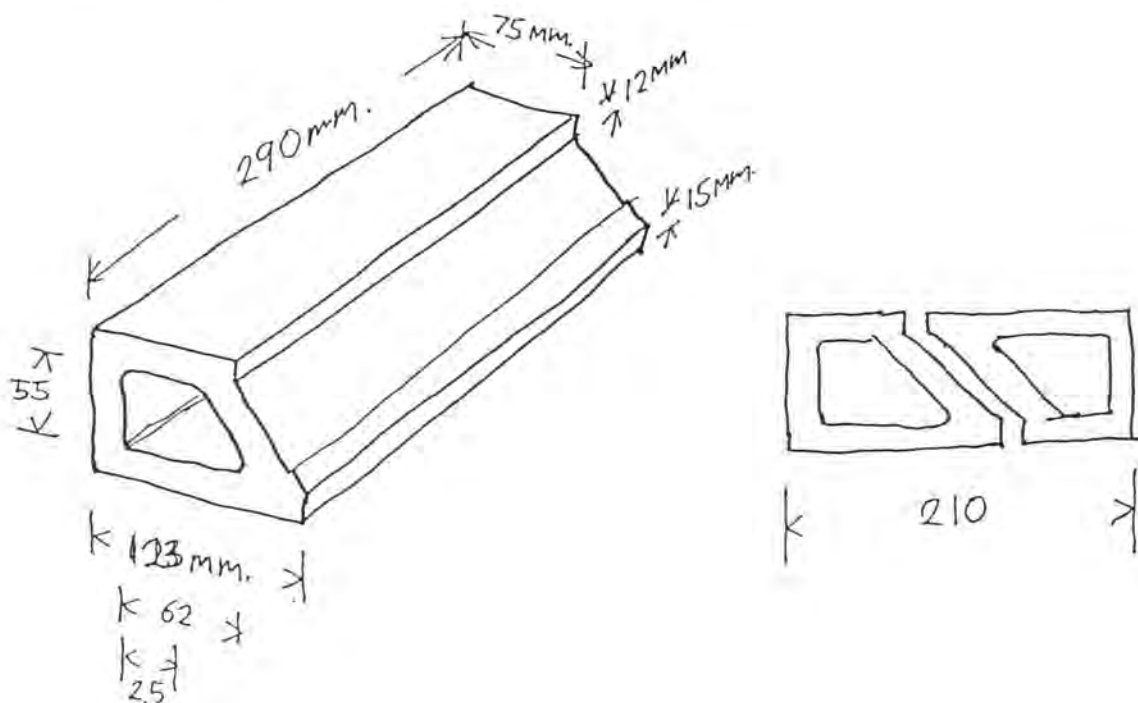
Fig 6 Henry Roberts' brick from Horton
 left: single brick with dimensions in millimetres
 right: two bricks as walling

Access to the excavation site at Horton was through a back garden. Here weighing down the lid of a coal bunker were two examples of Henry Roberts' patent interlocking hollow bricks of 1849 (fig 6). Allowing for a mortar joint between them, they form a wall about 210 mm ($7\frac{1}{4}$ in) thick (fig 6 right). They were used in the construction of the model cottages erected for the Great Exhibition of 1851. It is not certain where these bricks could have been made, but they match 6 bricks made in the Verwood area of Dorset and bricks from Hampshire.

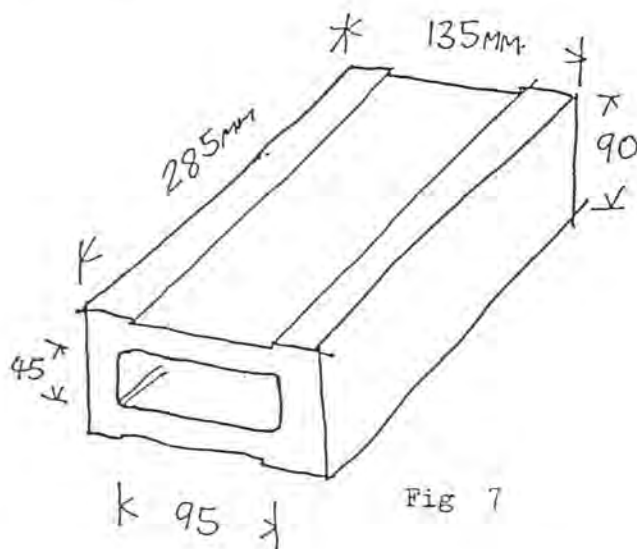
Fig 7 Henry Roberts' brick from Edmondsham House.

During a visit to Edmondsham House, near Cranborne, Dorset, I saw another hollow brick which appeared to belong to the same 'kit'. The body of these examples was dark red flashed to purple, with some fire-cracking in the rectangular block; similar to some bricks from the Verwood area, 3 miles south-east of Edmondsham and 5 miles north-east of Horton. The examples seen appeared to be unused; no complete building in the area is known to have been built of them. They why should they be found in rural Dorset?

Besides the Henry Roberts' brick (fig 7) I also found in the kitchen garden of Edmondsham House coping bricks (fig 10 and 11) and edging tiles (fig 12). Most of the vegetable and herb beds were edged with red hand-made briquettes measuring 155 mm by 80 mm by 55 mm, laid diagonally on edge. In and around the sheds was an area of paving consisting of pammments, measuring 190 mm by 190 mm by 50 mm.

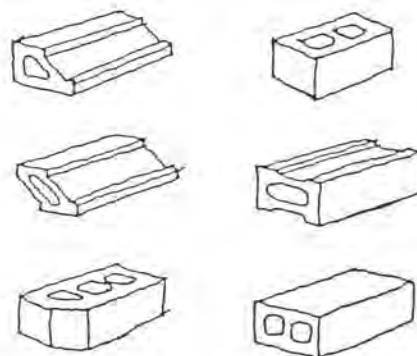
Fig 8 Henry Roberts' bricks as shown E. Dobson and A.B. Seale, *Bricks and Tiles* (1936 edition).

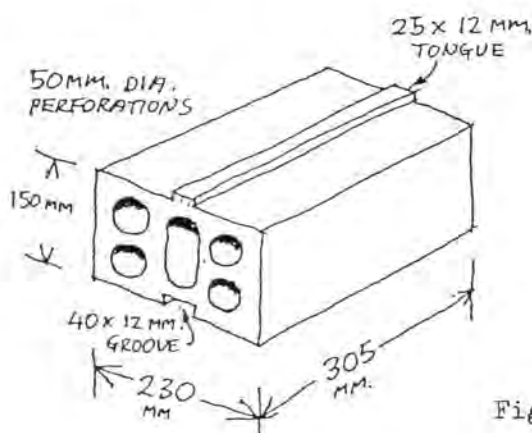
Fig 9 Brick found near the British Waterways Museums, Stoke Bruerne, Northamptonshire, in 1966, and believed to have been made locally.

The type was not popular because vermin could live in the perforations.

Fabric: light red, extruded wire-cut.

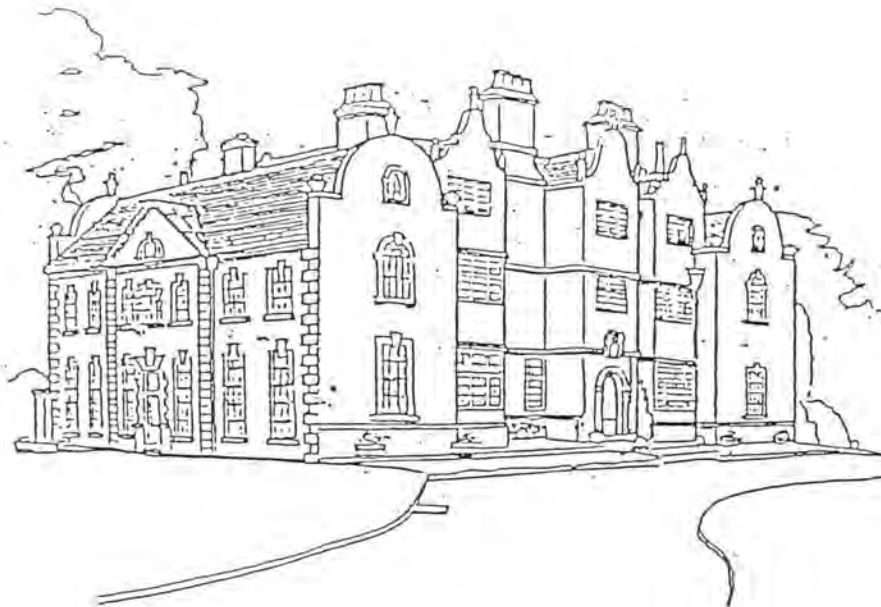
Fig 10 Edmondsham House: a multi-period brick house in Dorset

The house itself is of Tudor origin, much altered and extended. The 1745 wings are of hand-made pinkish-red bricks measuring 225 mm by 110 mm by 65 mm, with four courses rising 290 mm, still bearing traces of cream colour-wash. In the library lobby are estate maps of November 1840 and 1857 which indicate brickmaking activity quite close to the house. Names include 'Marlpit Hill' at grid ref SU/065119, 'Brick Kiln Piece' at grid ref SU/065114, and 'Brick Closes' at grid ref SU/065113.

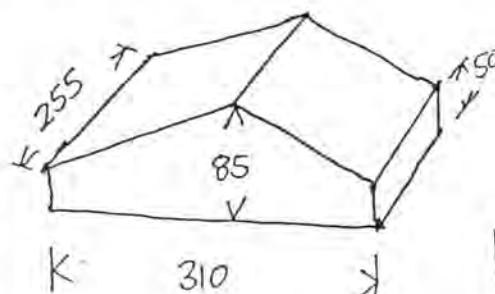
Fig 12 Coping brick from Edmondsham House

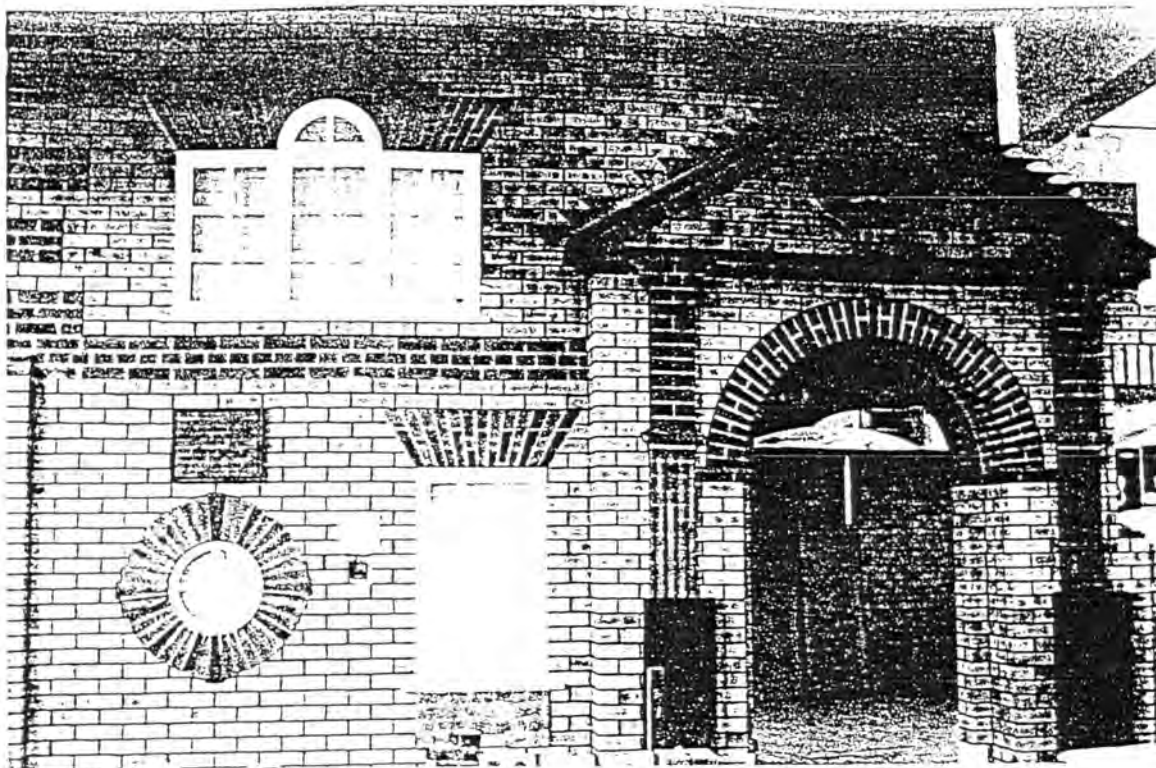
Fig 1 General view of wall with gauged brickwork at Bedford College of Higher Education, Bedford. Lighter colour is grey brick; darker colour is red brick, including the gauged brickwork.

Consequently over four years, and as the skill has become more familiar, an extremely fine Georgian facade has been built as a permanent feature and showpiece of the brick workshop. This is not only a testament to the skills learnt but has already been the focal point of much architectural interest and 'in workshop' training for outside visitors. The construction of the Venetian Wave arch by third-year students was the subject of a commissioned video for the Research and Technical Advisory Service of English Heritage, who will employ this in their quest to build up a library of the more highly skilled operations, now sadly neglected skills, required in today's conservation and restoration environment.

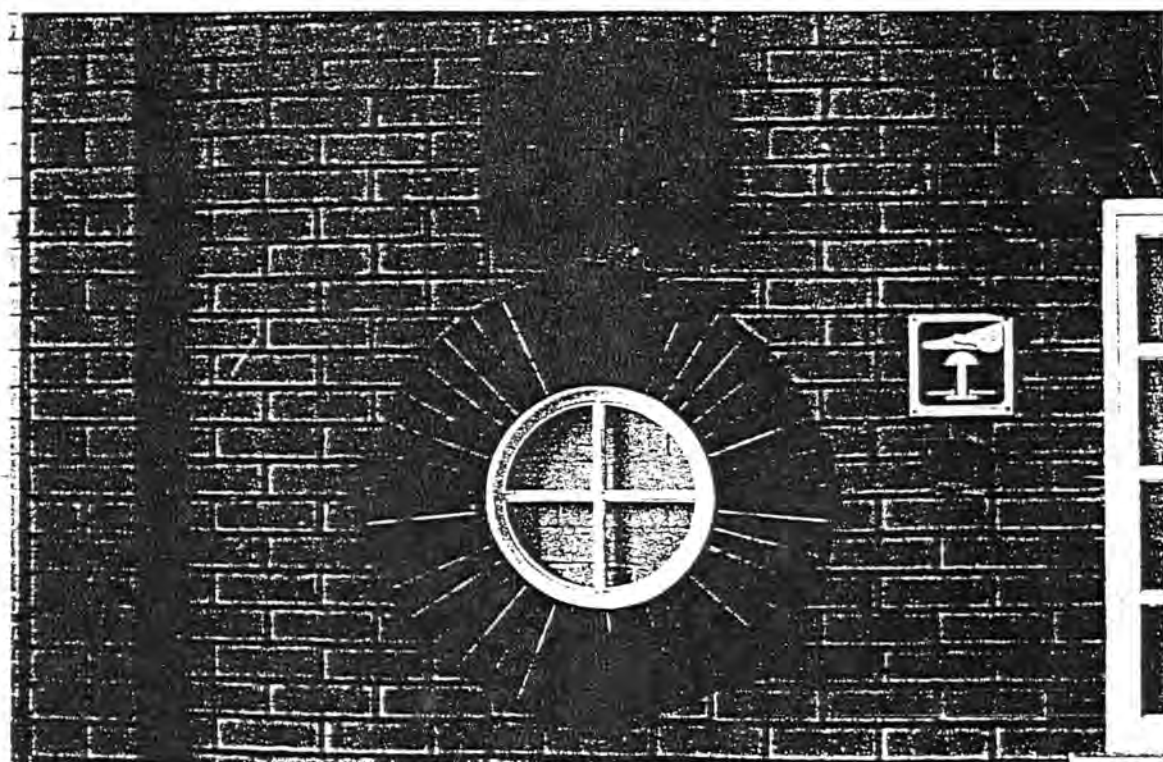
Fig 2 Detail of round window outlined in gauged brickwork.

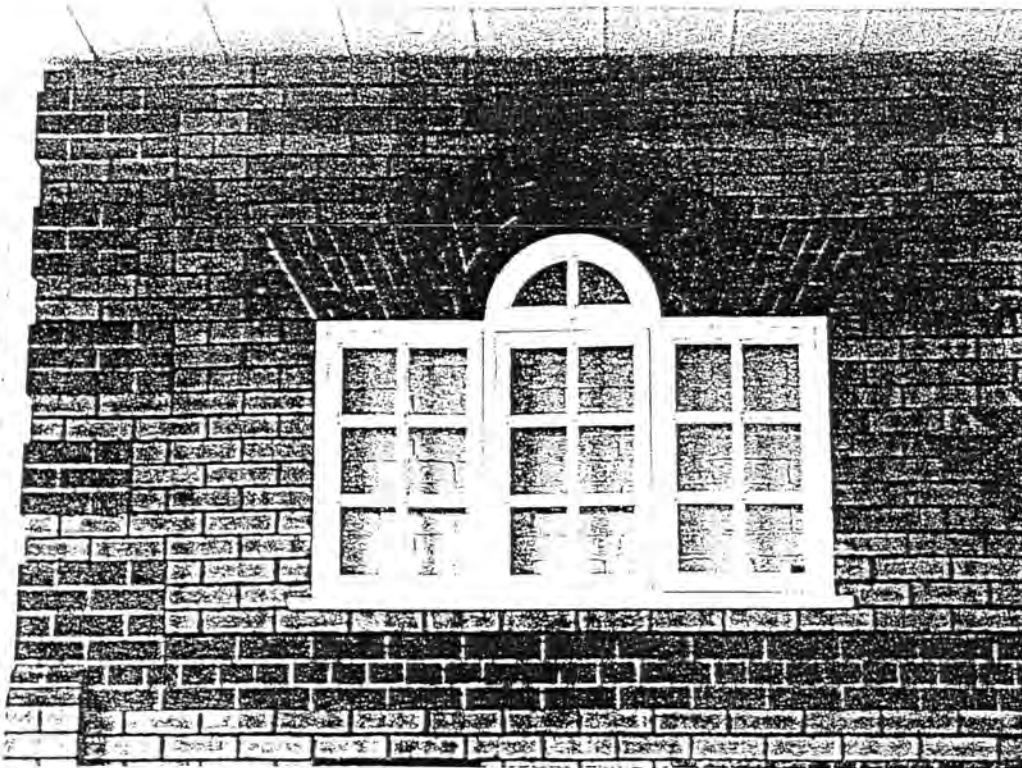
Fig 3 Gauged brickwork above Venetian window, in the wall at Bedford College of Higher Education, Bedford.

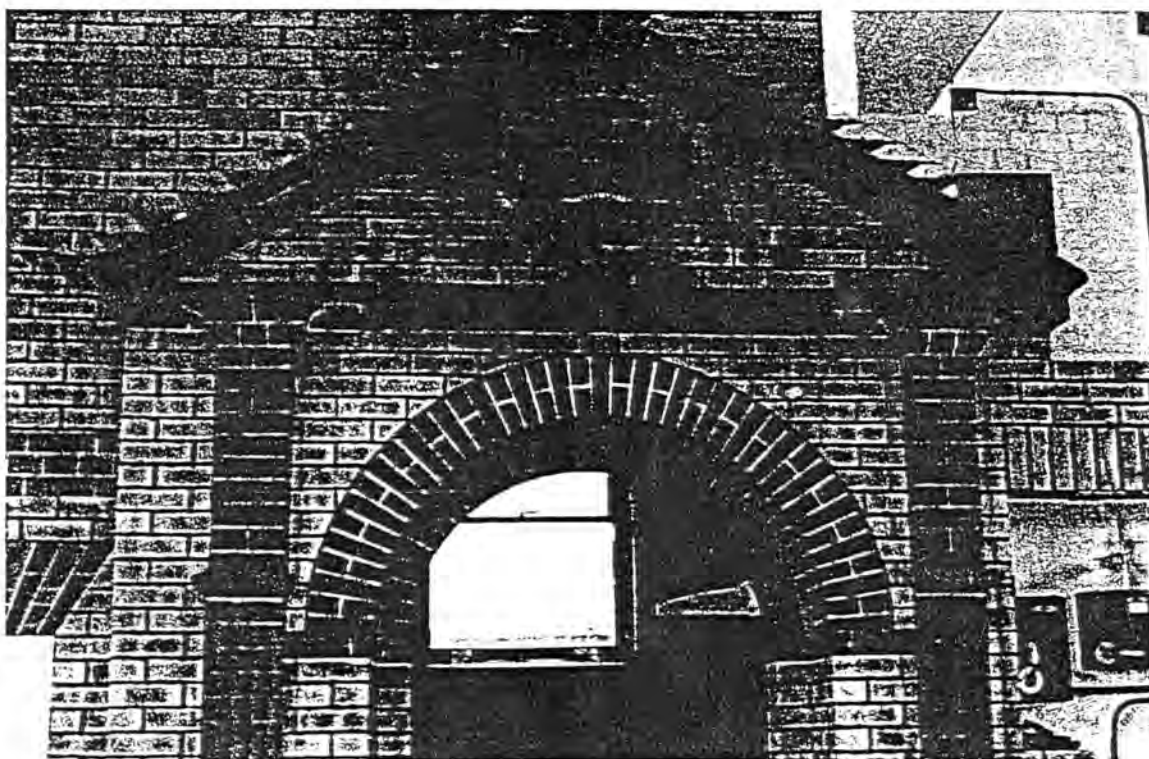
Fig 4 Door arch and pediment in brickwork wall at Bedford College of Higher Education, Bedford.
